Pressure Treated Wood for Outdoor Structures

Technical Data

1. What is “Marvel Wood”?

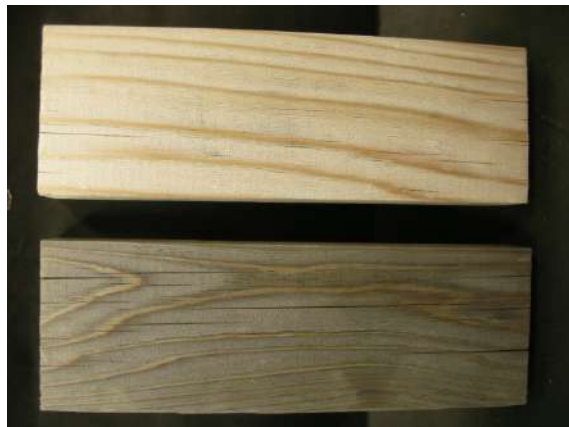
"Marvel Wood" includes the fungicide, therefore the black discolorations caused by mold will be reduced. A below photo is the results of the outdoor weathering test, "Marvel Wood" and Non-treated wood were exposed in one year. "Marvel Wood" was keeping the appearance of wood, but Non-treated wood had the black discolorations caused by mold.

Results of the outdoor weathering test in one year

Top : Marvel Wood

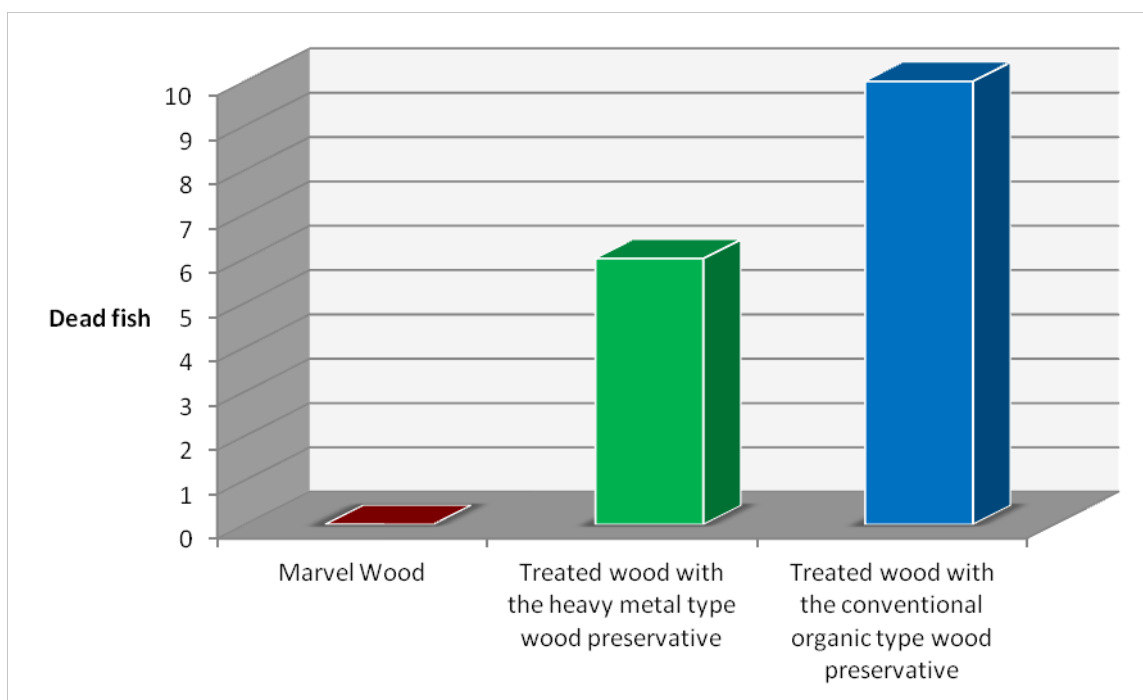
Numbers of the Dead killifish after 96h exposure

After acclimated 10 killifishes to 4L dechlorination water in the test tanks, the test was started by put the treated wood with 3 type wood preservatives written on table 1 under the test water. The treated wood is Japanese cedar sapwood, the size of 20mm x 20mm x 10mm, and used three pieces(=total volume 12cm³) each the test tanks. The dilution rates of each wood preservatives were adopted the recommended dilution rates for exterior use. The toxicity was assessed with the dead number at the time of an exposure endpoint of 96 hours.

Amount of impregnate (kg/m ³)	Total volume of treated wood (cm ³)	Dead / All (number of fish)
Marvel Wood	819	12	0 / 10
Treated wood with the heavy metal type wood preservative	843		6 / 10
Treated wood with the conventional organic type wood preservative	828		10 / 10

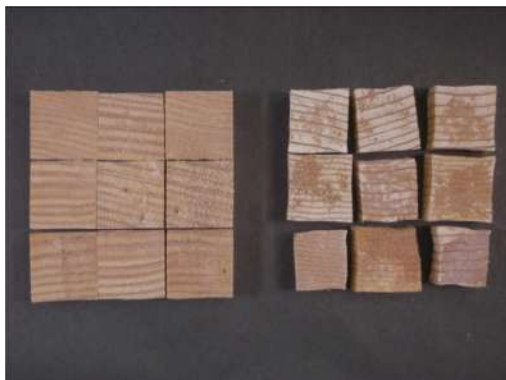
The test pieces after the test. (Left: Marvel Wood, Right: Non-treated wood)

A resistance of “Marvel Wood” to wood decay fungi was evaluated with the laboratory test in accordance with Japanese Industrial Standard. The results showed that a resistance ability of “Marvel Wood” to wood decay conformed to the performance standard.

Experimental fungus	Weight decrease rates (%)	
		Average	Standard deviation
Marvel Wood	<i>Fomitopsis palustris</i>	– 1.4	0.0
	<i>Trametes versicolor</i>	– 1.3	0.1
Non-treated Wood	<i>Fomitopsis palustris</i>	54.8	6.0
	<i>Trametes versicolor</i>	49.0	4.5

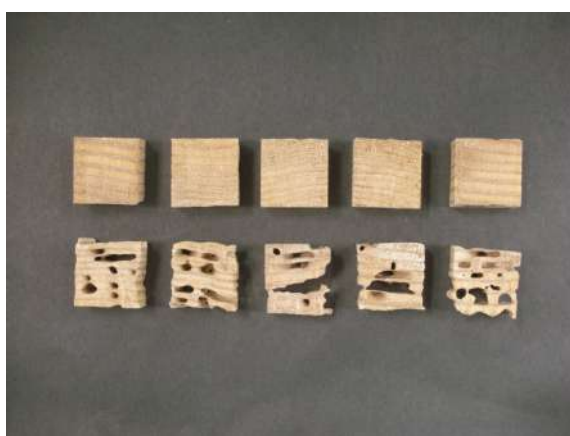
The test pieces after the test. (Top: Marvel Wood, Bottom: Non-treated wood)

Mortality rates (%)		Weight decrease rates (%)	
	Average	Min – Max	Average	Min – Max
Marvel Wood	100	100 – 100	1.3	1.2 – 1.5
Non-treated wood	8	7 – 9	31.8	29.4 – 36.0

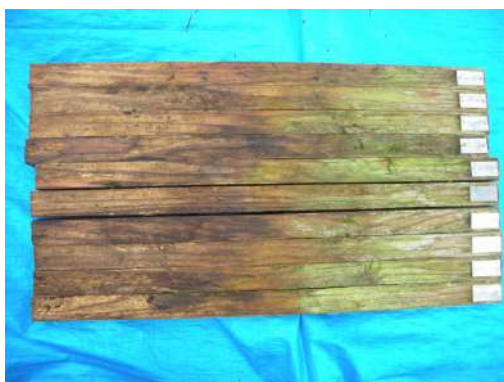
Marvel Wood

(As of 10 years from the test start)

The test results are given below in Table 8. As of 6 years from the test start, “Marvel Wood” was not observed the noticeable fungal decays or termite damages in all portions above ground, ground contact and underground. Conversely, Non-treated wood was observed many serious fungal decays and termite damages, greeted the useful life provided JIS K 1571 in 19 months from the test start. The useful life of “Marvel Wood” was more than 3 times as much than Non-treated wood and conformed to the performance standard in JIS K 1571.

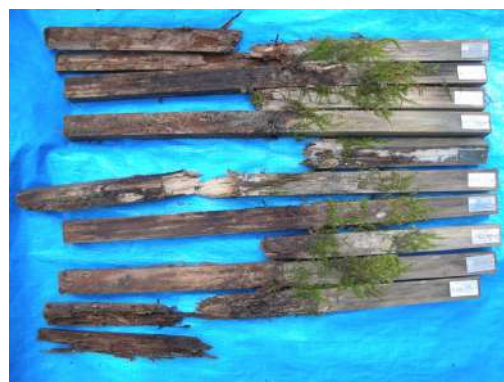
Non-treated Wood

(As of 3 years from the test start)

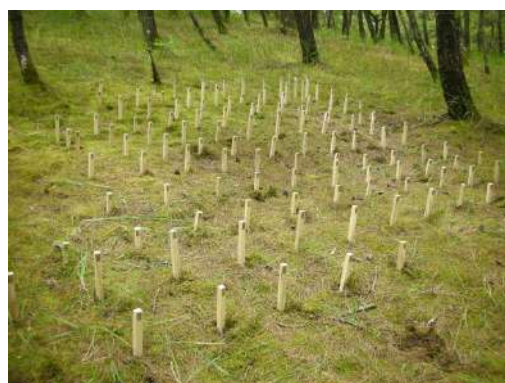
A look of the field test with stakes

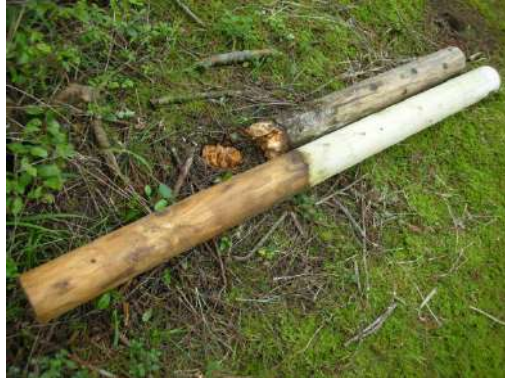
A look of the posts as of 2 years from the test start
Top: Non-treated wood (broken) Bottom: Marvel Wood

As the results of field test with posts, “Marvel Wood” had nothing decays or termite damages, but all of non-treated wood had mild to severe decays and termite attacks.

This test had been conducted with using Japanese cedar and Japanese cypress posts (diameter 100mm x length 1500mm). “Marvel Wood” and Non-treated wood were prepared, and the test was started by buried the half (750mm) of these in the ground. The damage conditions were observed regularly.

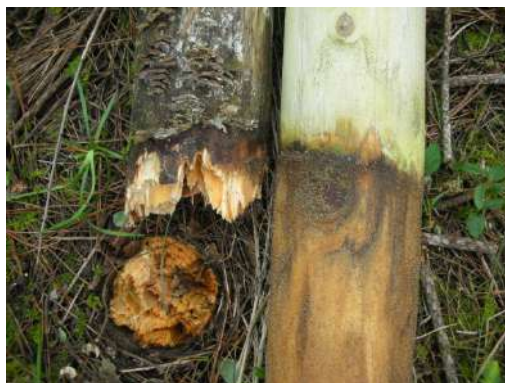
Magnified photo of the broken portion on posts
Left: Non-treated wood (broken) Right: Marvel Wood

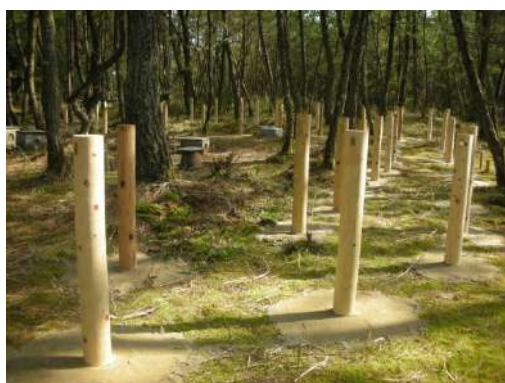
A look of the field test with posts

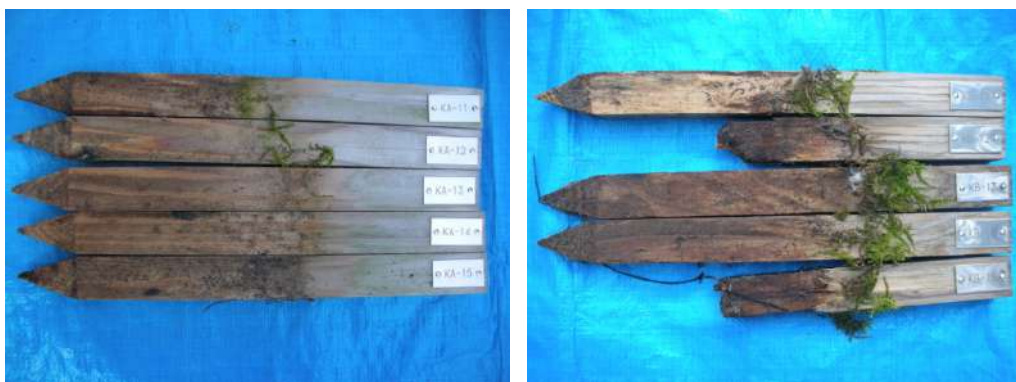
The test stakes after the test. (Left: Marvel Wood, Right: Non-treated wood)

The test results are given below in Table 10. As of 2 years from the test start, “Marvel Wood” was under 10 concerning the termite damage indexes and conformed to the performance standard in JIS K 1571.

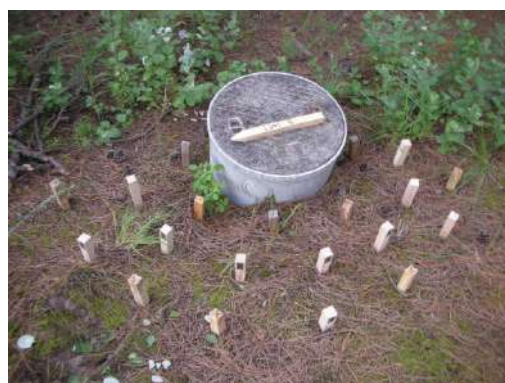
A look of the field test for termites

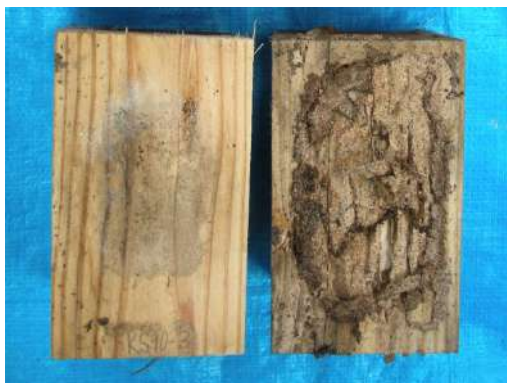
The test wood of Japanese cedar
Left: Marvel Wood
Right: Non-treated Wood

Okinawa prefecture is the most activation area in Japan regarding termites activity. "Marvel Wood" was evaluated with the field test focused on termites in Okinawa, but "Marvel Wood" had nothing termite attacks. In contrast, all of non-treated wood were observed severe termite attacks.

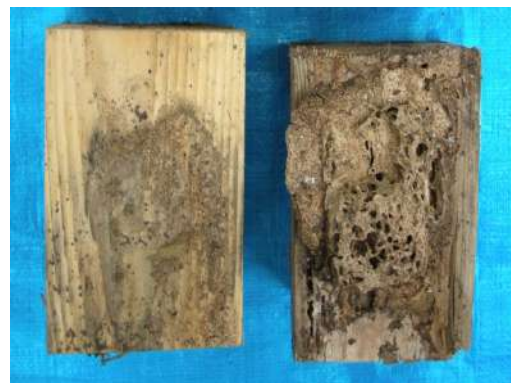
The test wood of Western hemlock
Left: Marvel Wood
Right: Non-treated Wood

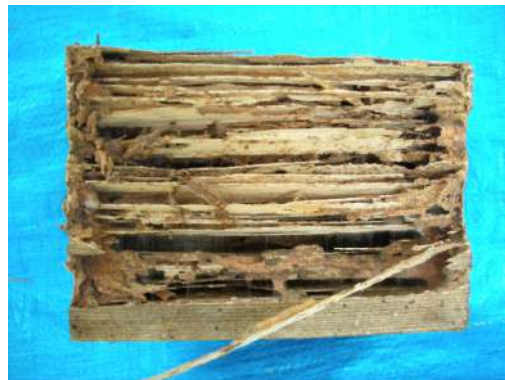
Damage example of non-treated western hemlock
